**210 MW Bison 4 Wind Project, Minnesota Power (PSC Case No. PU-13-127)**

## Permit Compliance Review

NDPSC Contract No.: PU-688-13-EE

Reporting Period: September 26<sup>th</sup>, 2013 – August 1<sup>st</sup>, 2014Prepared By: Houston Engineering, Inc. / Emmy Baskerville, Environmental Scientist and Bart Schultz, Project Manager

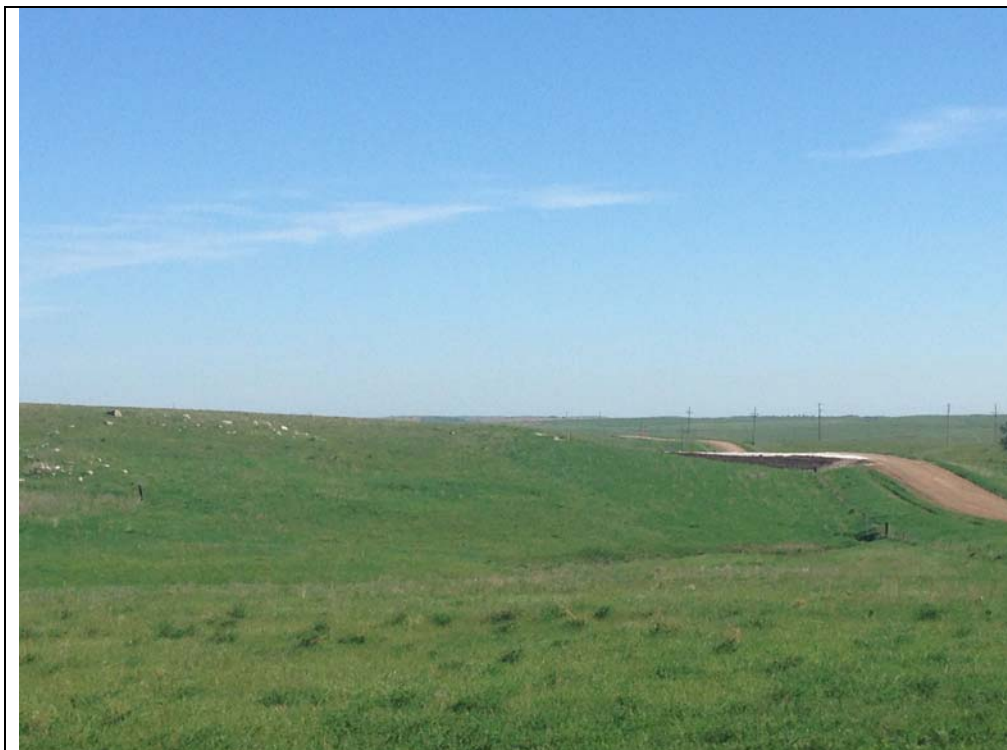
**Photo 1:** Access road for Turbine 463, from the south facing north. The staked archaeological / historic area can be seen in the foreground, and the access road construction avoids this identified area.

Pole 463 - road rutting (County gravel)  
\* ~~active~~ construction of access road ~~obs.~~ ~~obs.~~ complete

\* silt fence installed  
\* Soil separation (top) obs.  
\* avoidance of arch/hist res.

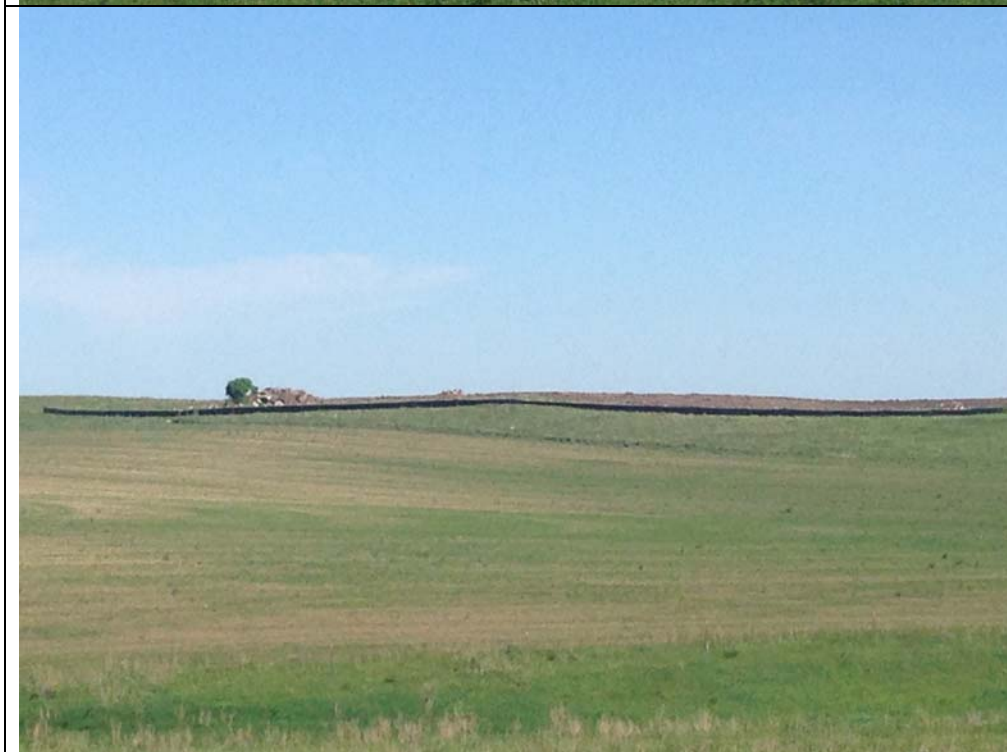
**Photo 2:** Silt fencing surrounding the pad for turbine 463. From the southeast facing northwest from 28<sup>th</sup> street.

All areas observed under construction had appropriately placed erosion control (silt fencing). In addition, appropriate construction signage along public roads was observed within the heavy equipment areas. Tree removal activities had occurred and the debris had been removed from the site (no debris was observed). One archaeological / historic area adjacent to turbine 463 was identified. HEI observed that the access road construction had completely avoided this area, complying with the permit stipulations. Rough road rutting was noted along 59<sup>th</sup> Avenue, adjacent to turbine 463. The road near turbine 463 will require some restoration.

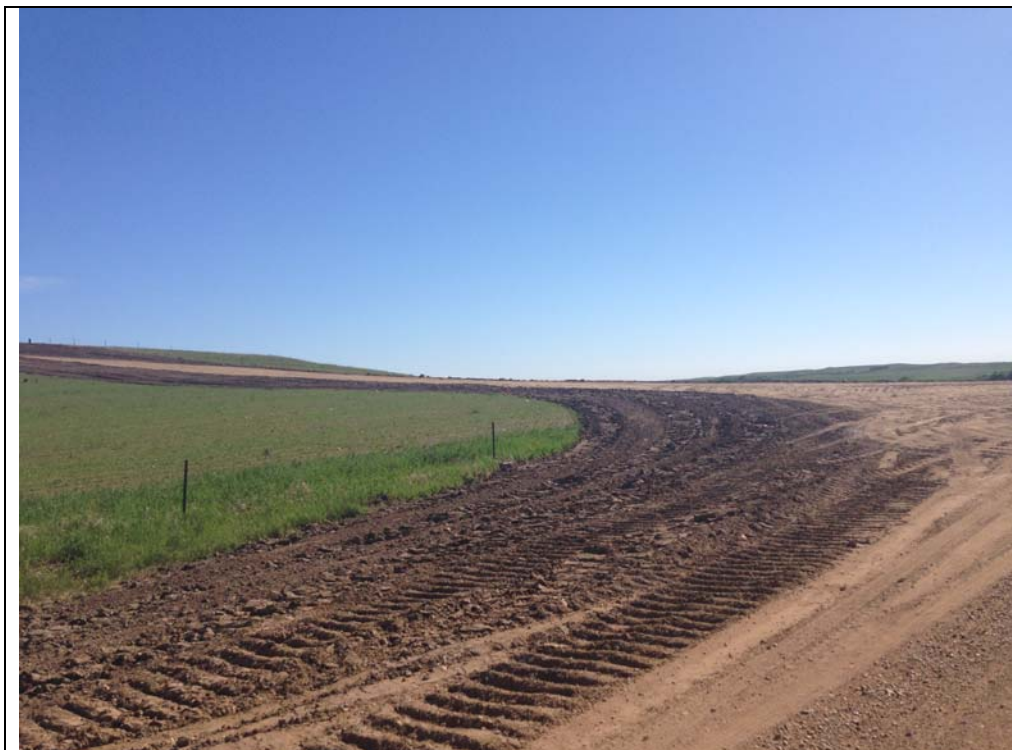
**Photo 3:** Access road for turbine 462. The county road conditions in this area were relatively rough, however active construction equipment was in the area. This roadway will need to be restored to the original condition.

\* ~~active~~ construction of access road / complete?  
appears

\* silt fence in place

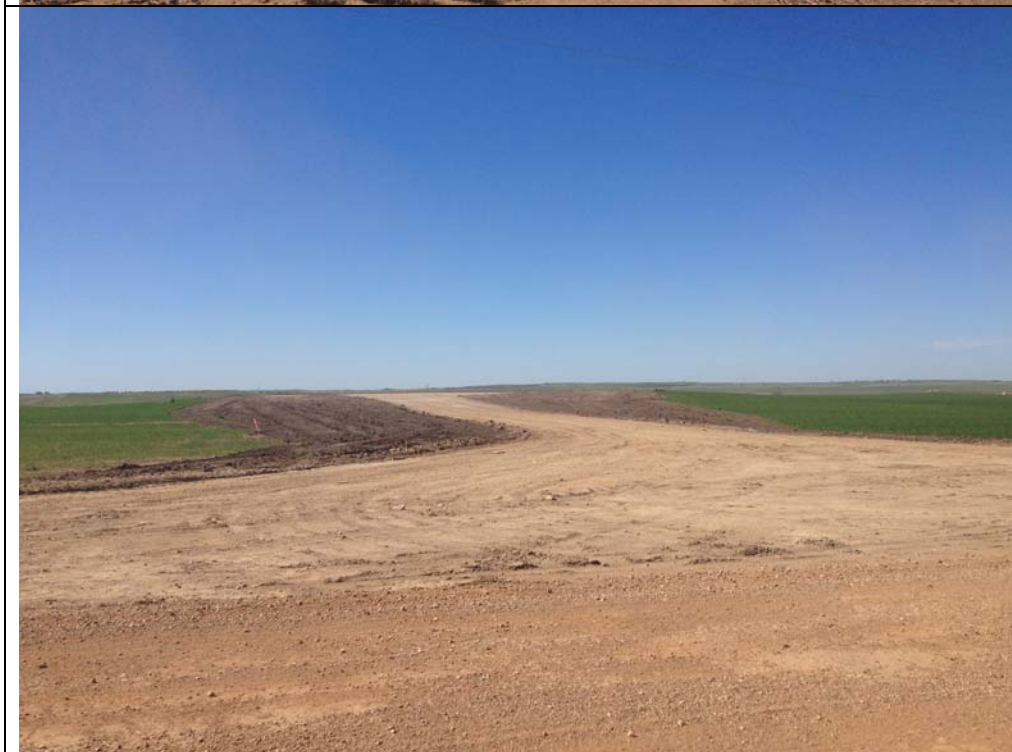
**Photo 4:** Access road (foreground) and pad (background) for turbine 461. Silt fencing was observed surrounding the pad.

\* ~~active~~ looks like access rd.  
complete?  
- silt fence in place

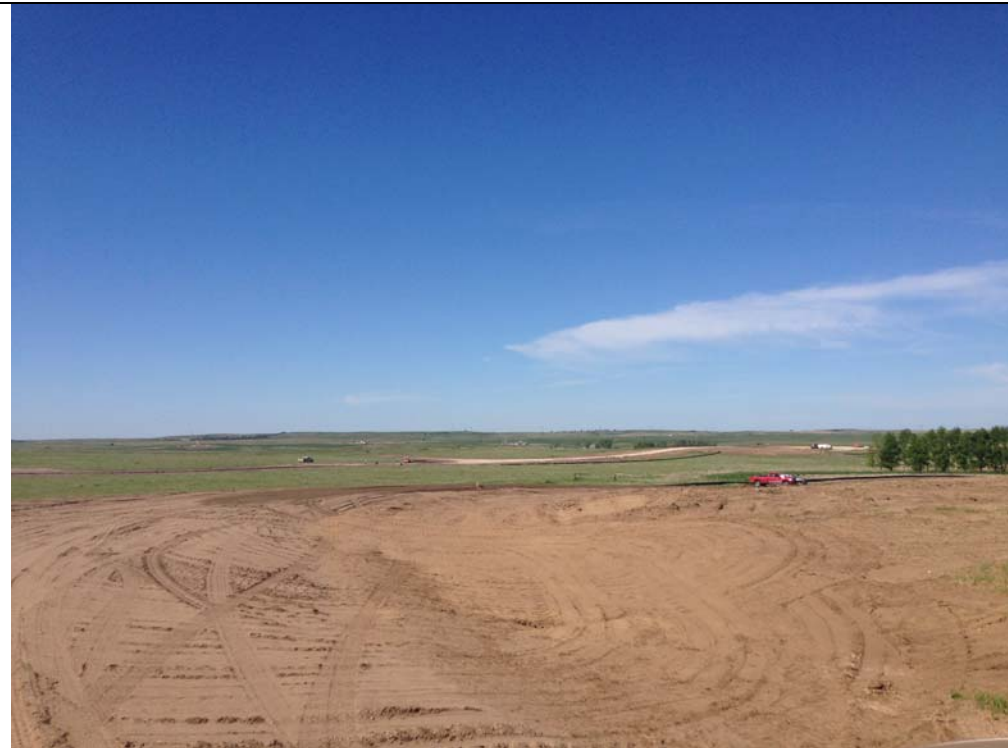
**Photo 5:** Access road and pad construction for turbines 452 (foreground) and 459 (background). Silt fencing observed.

active const. of access road  
silt fences in place  
- const. equipment obs.

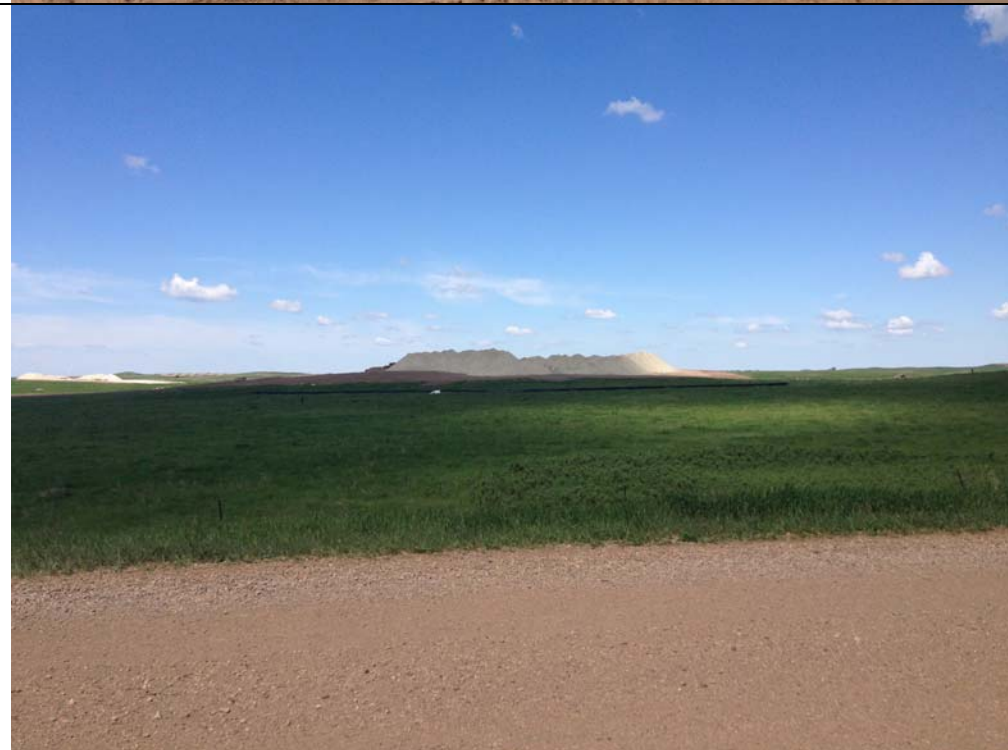
**Photo 6:** Active construction on pad for turbine 420. Silt fencing observed surrounding pad.

- active const of <sup>access</sup> ROAD / PAD
- silt fences in place
- tree rem. appears complete

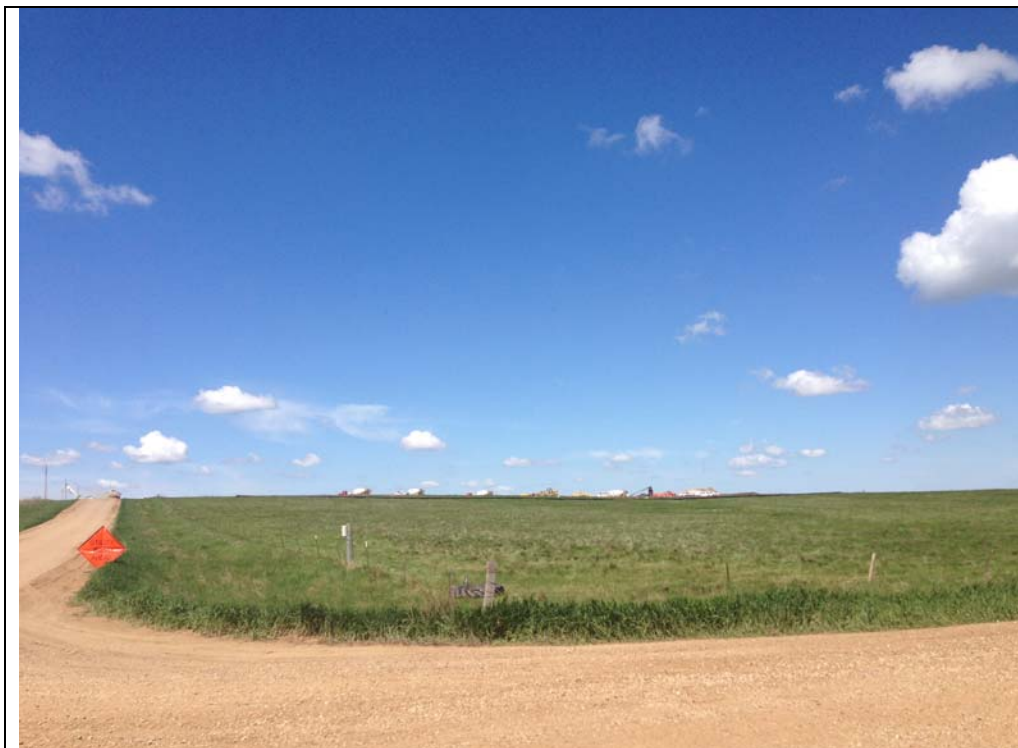
**Photo 7:**  
Laydown area.

- active const. of access ROAD / PAD
- concrete trucks obs
- public ROAD SIGNAGE obs
- silt fence in place

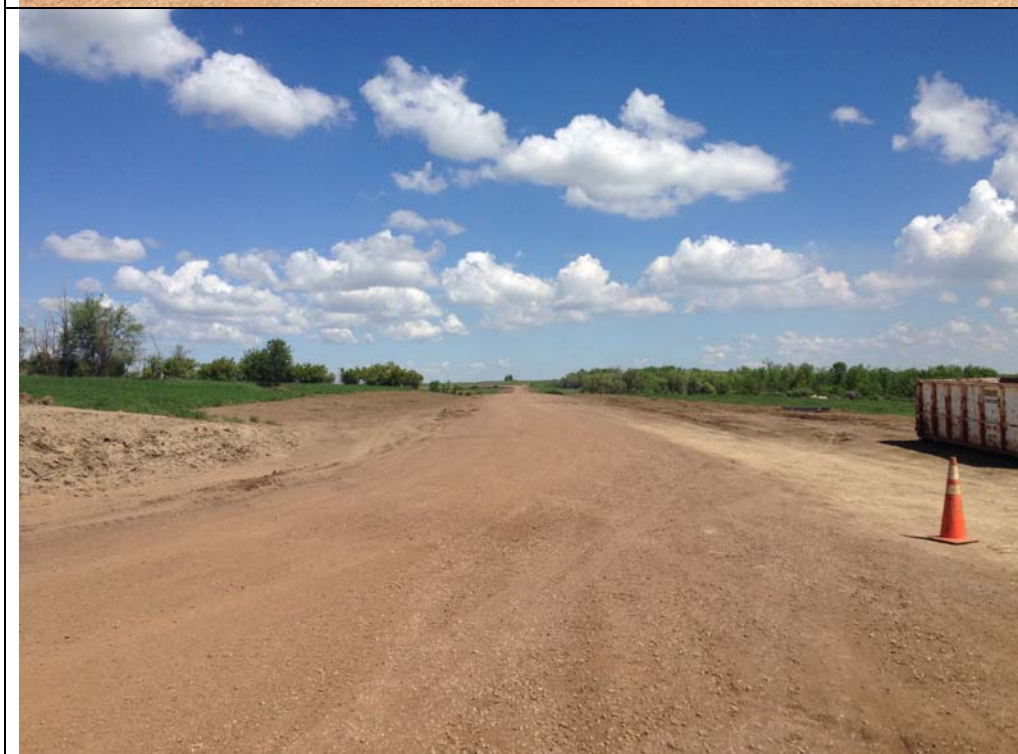
**Photo 8:**  
Completed  
access road for  
turbine 421,  
from the south  
facing north.

- access ROAD complete, no ~~other~~ const. observed
